Manhole Inspection Summary

Manhole # S25SS1031MH

Printed On: 12/17/2008

Location Address: **301 ELMHURST RD**

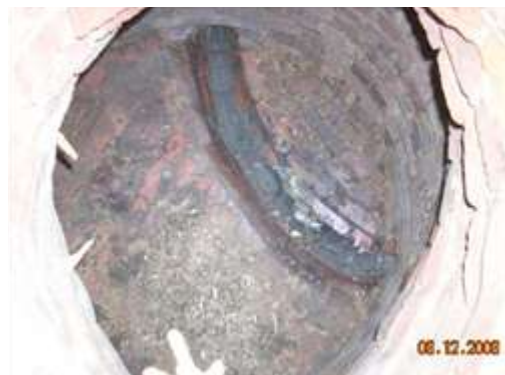
Top View

Corroded and missing steps. Evidence of surcharge - Bench debris. Channel debris.

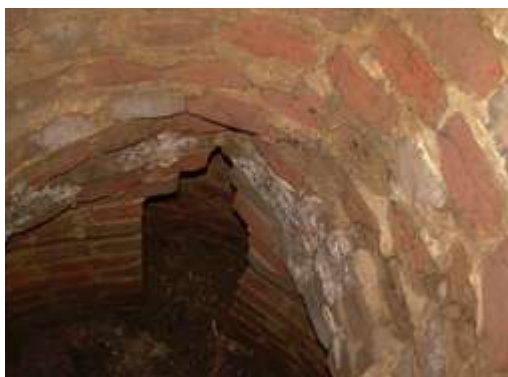
Defect

Void in Barrel wall.

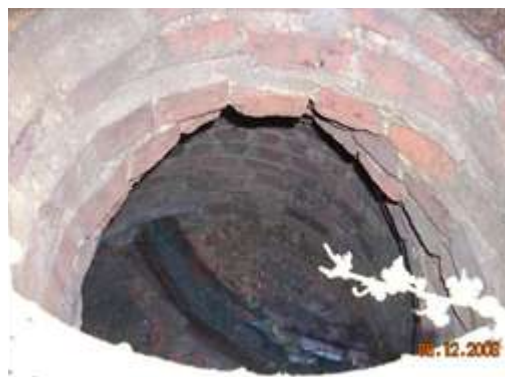
Defect

Adjustment, Corbel and Barrel infiltration.

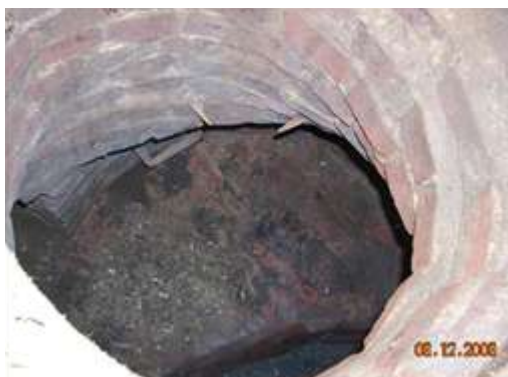
Defect

Adjustment, Corbel and Barrel infiltration - other side.

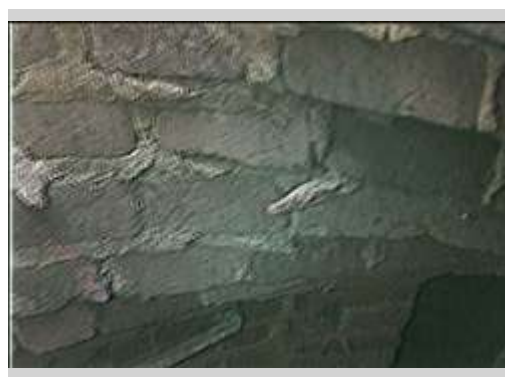
Defect

Corbel deterioration and infiltration.

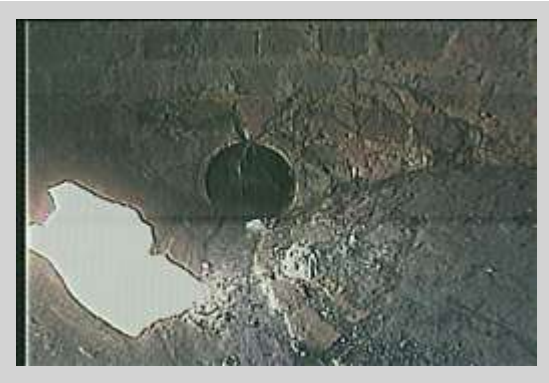
6 in. Circular Gravity Sewer Pipe Out @ 12 O'Clock

Barrel deterioration, root intrusion and infiltration.

Infiltration: **Evidence** Pipe Seal Cond: **Roots**

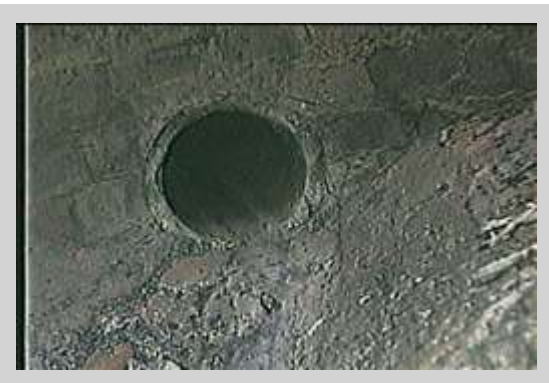
6 in. Circular Gravity Sewer Pipe In @ 3 O'Clock

Infiltration: **Evidence** Pipe Seal Cond: **Unknown**
